Solola, Guatemala

**KANSAS CITY
PROFESSIONAL CHAPTER**

Assessment Report

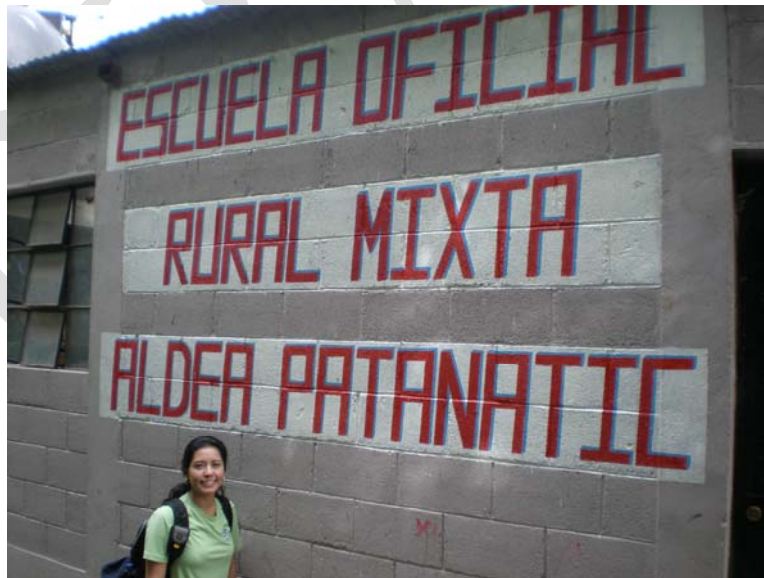
The school representatives stated their concern with the current sewage system that drains directly to a tributary of Lake Atitlan untreated and were worried about the health of the lake and the community. They stated there were too many kids for two bathrooms and that the system often clogged and often overflows onto the basketball court. Trash collection or solid waste disposal and material for disaster or emergency relief were also mentioned as items of concern.

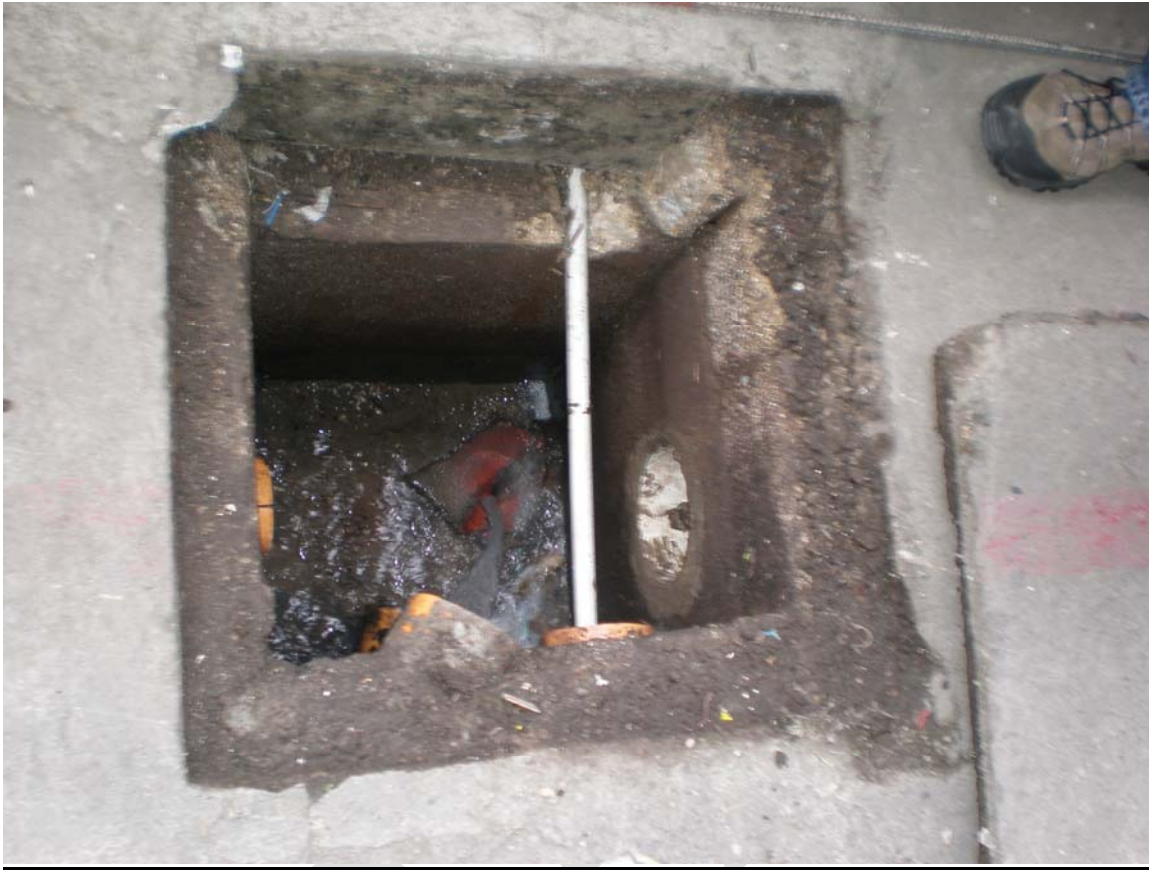
The existing water source is a fresh spring located 10 to 15 km away. The school has a regular and consistent source of water. There appeared to be no temporary water supply storage available at the school. Their existing water line runs inside a sanitary pipe and needs to be relocated due to the high potential for contamination.

Figure 1. Waterline (white pvc pipe) entering the sewer pipe (orange pvc pipe).

The existing waterline needs to be relocated and removed from the sanitary sewer pipe. This can be easily accomplished using pvc pipe and finding an alternate connection route. Rain harvesting may be an alternative for increasing their existing water supply

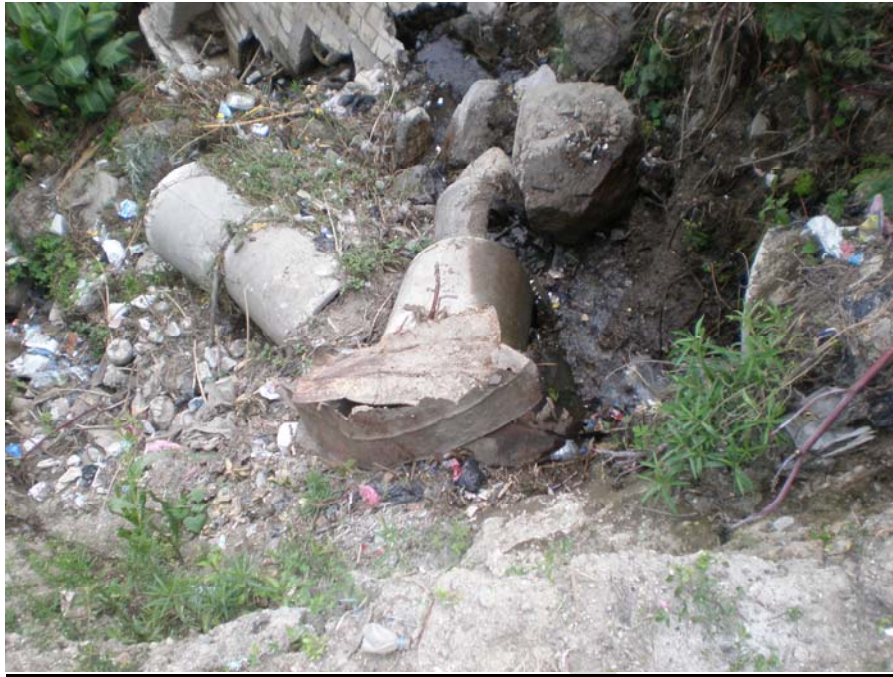
The sanitary system currently consists of a piping system that outlets to a tributary of Lake Atitlan, with no treatment. Three families located upstream are also connected in to the system. The piping clogs regularly and overflows into the school's basketball court.

Figure 2. Wastewater outfall location for school's sewage.

The school owns some property nearby and they'd like to look at some form of treatment using the property available. There is another school close by (North of this building) and they would like to see a project with a sewer line to both schools. They suggest construction of a line north of the channel in an area where it won't be as susceptible to hurricane damage. To alleviate clogging the pipe's existing grades should be verified to ensure proper flow. Treatment possibilities and feasibility should be the number one priority for public and community health reasons.

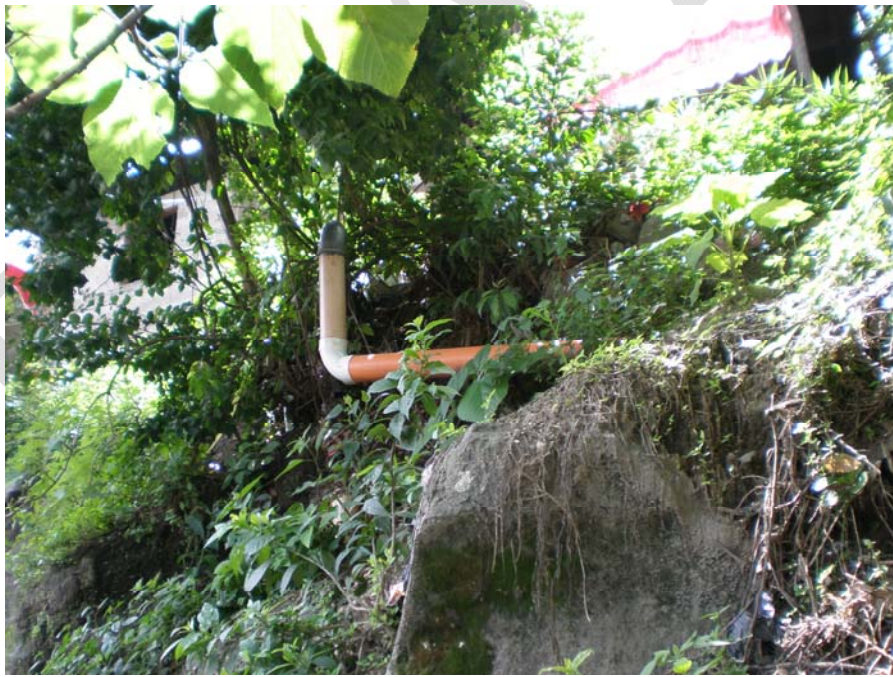
Figure 3. Sewer piping carrying sewage to Lake Atitlan.

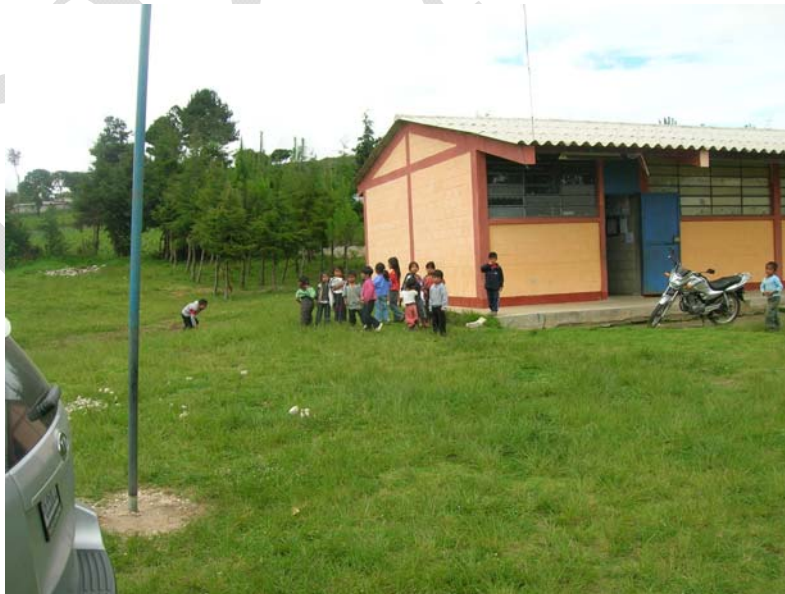
Raul stated that the water supply was inconsistent and not available some days. He collects water in the afternoon for classes the next day. The water often is available at nights, but the school has limited storage capabilities. The school does have government built bathrooms, but they can only be used when water is available. The bathrooms remain locked when school is not in session. Several other items that were addressed included the kitchen's lack of ventilation, the need for a meeting place, and the desire to build a library. Raul stated that the community is very involved and has a desire to see their city grow!

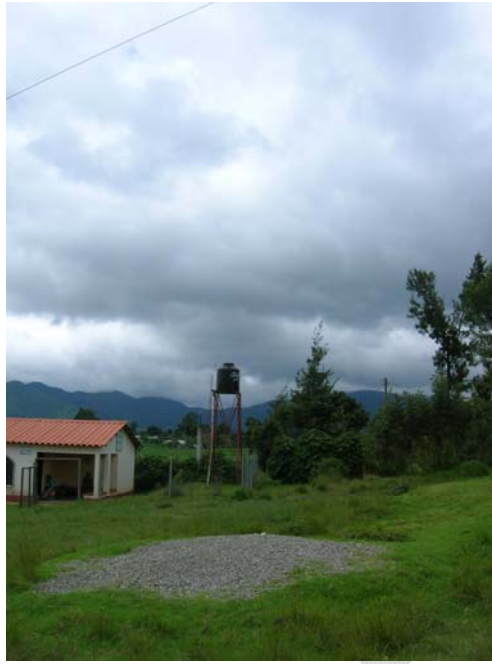
The town has purchased land in hopes of constructing a groundwater well. The well location was not visited, but with further investigation may be a feasible water source. The clinic next door has a RotoPlas tank which is used for water storage. It was not noted if the clinic's water supply was sufficient.

Figure 4. Rotoplas tank located at clinic adjacent to the school.

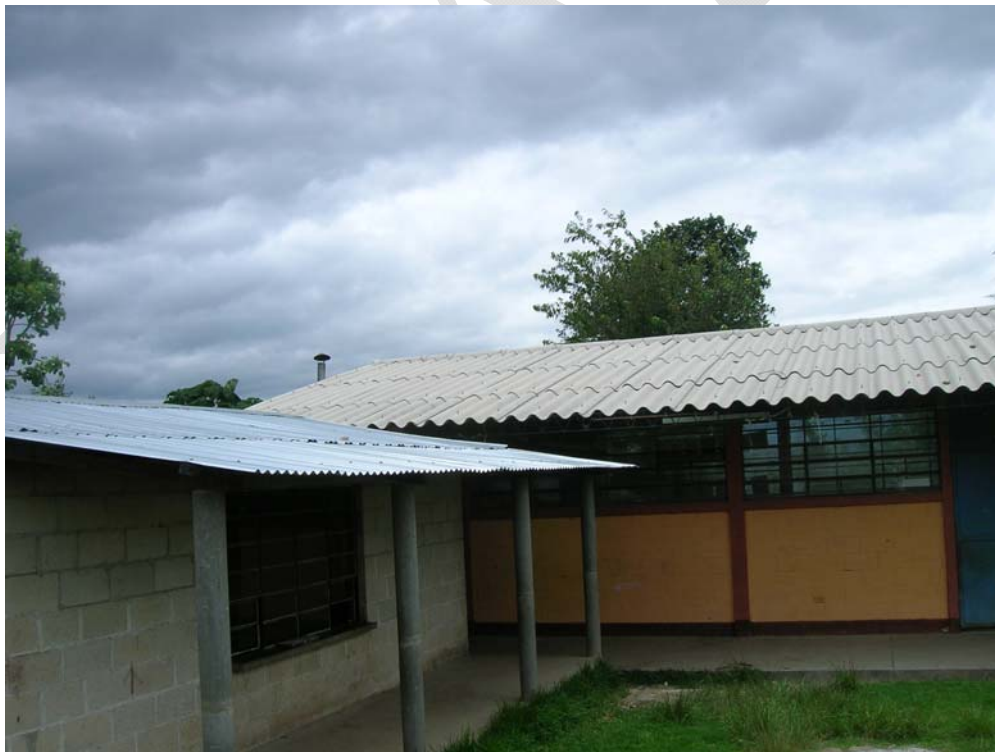
Figure 5. Roofs at school that could possibly be utilized for rain harvesting.

Rain harvesting may be a feasible solution if a metal roof is constructed between the two buildings. The existing roofs consist of material that would have to be investigated to ensure that the rainwater would not become contaminated; due to the possibility of asbestos in the roofing. However, rainwater harvesting could always be implemented and used for greywater applications.

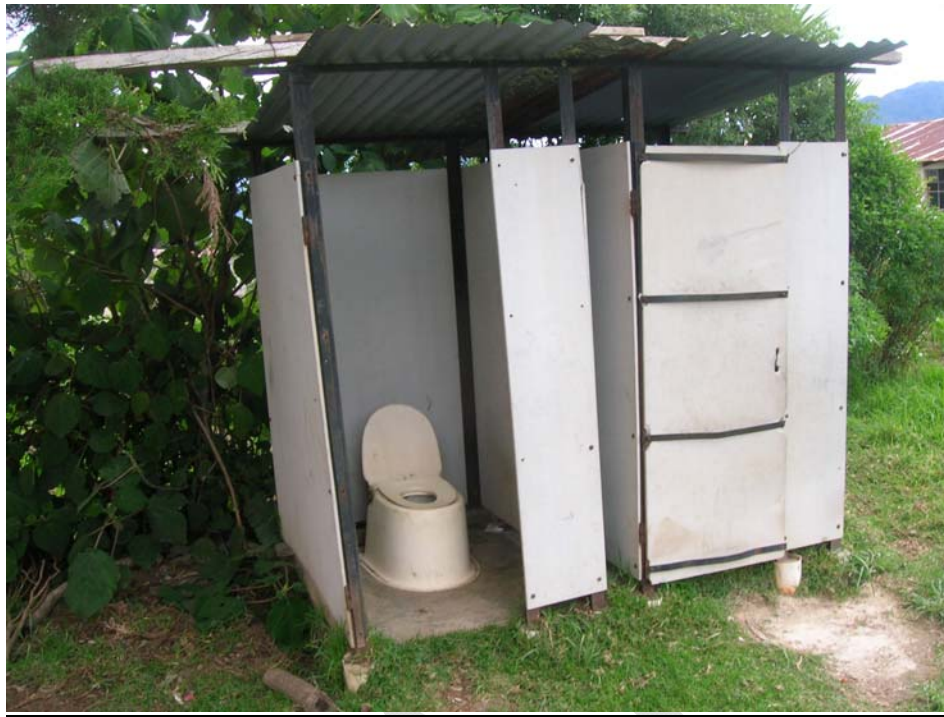
The school has two pit latrines that are utilized in case of emergency or when the school bathrooms do not have adequate water supply and/or are locked. The school has a bathroom building that is separate from the classroom buildings. The school's bathroom was built by the government (Social Investment Fund). It includes a cesspool/septic system that appears to have two separate holding tanks. It was assumed that ground infiltration was utilized for disposal or the outlet works. No outlet pipe or leach field was located. Raul stated that the system does not overflow and has never been cleaned out. Due to the bathrooms limited use this seems appropriate.

Figure 6. Emergency pit latrines.

The existing sanitary system appears to be functioning properly at the existing load being placed in the system. However, as water supply issues are resolved the daily loads will increase posing possible overflow concerns. The septic/cesspool system should be cleaned out and its capacity analyzed.

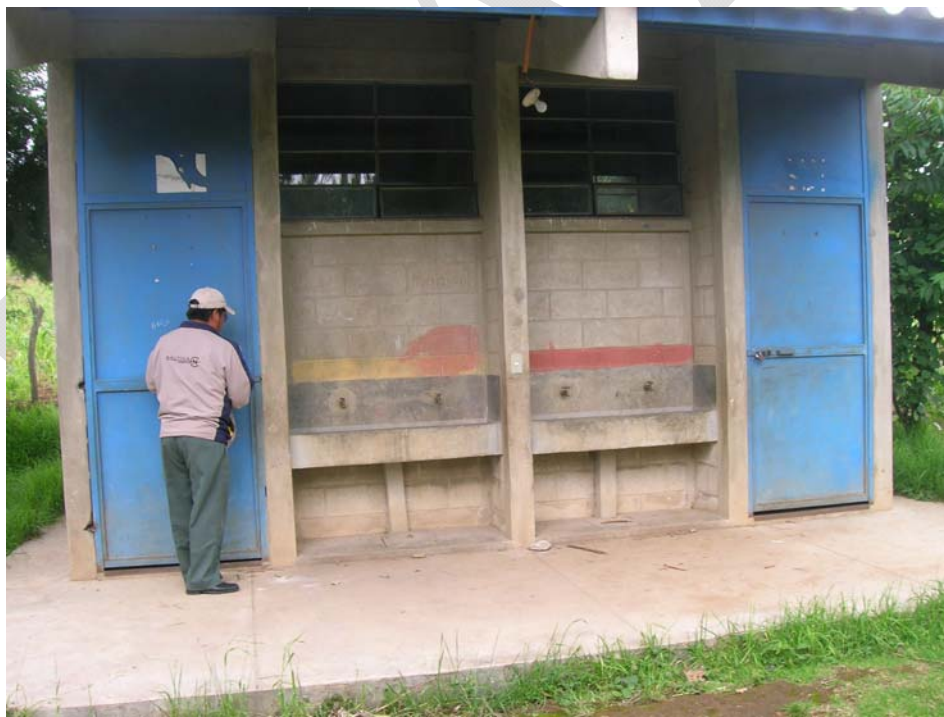
Figure 7. Bathroom building located adjacent to the classroom buildings.

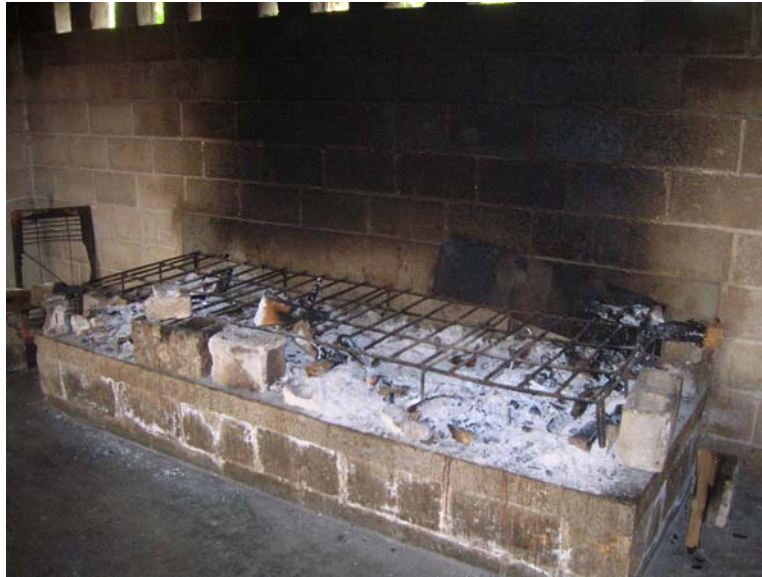
The school's kitchen is not properly ventilated. The women who cook complain about the existing conditions. We have an individual on our project team who has completed work in Antigua, Guatemala installing ventilation systems in homes. This same or similar approach could be applied to renovate this kitchen.

Figure 8. Fire pit located in building between classroom buildings.

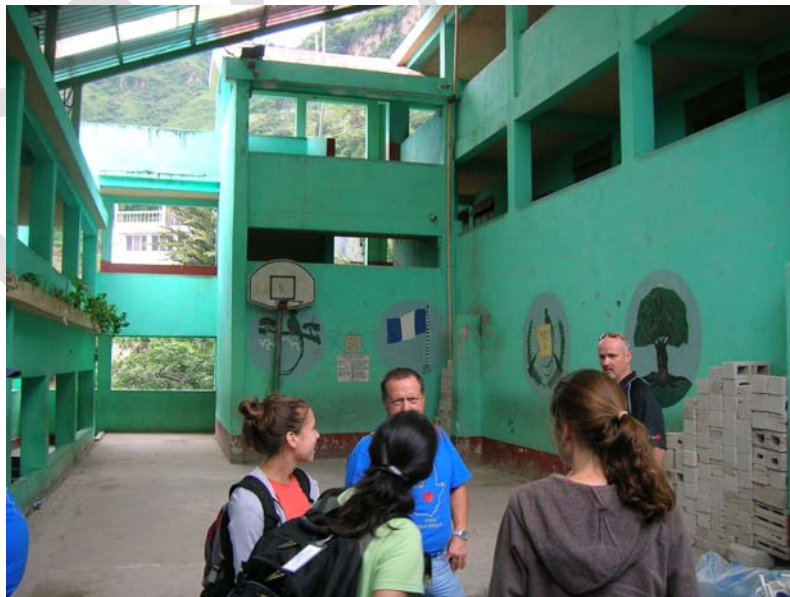
Vincentes stated the two biggest problems were the sanitary system and the lack of space. The septic system overflows often, and sometimes classes have to be cancelled due to the foul conditions. Because of the lack of space, the school has to turn down about 300 students a year. Vincentes stated it is his dream to have a clean environment for his kids and also to expand the school.

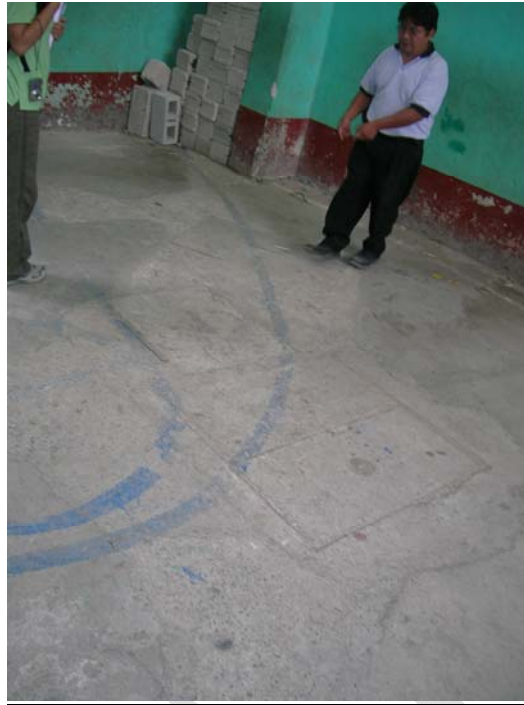
The sanitary system in its current condition is not functioning properly. There are student bathrooms on the second floor and a teacher's restroom on the third floor. Both of these restrooms are piped to a cesspool system located underneath the basketball court. It is uncertain if the pipes become clogged or if the capacity of cesspool is exceeded. It was assumed that with the amount wastewater created daily that the cesspool system is undersized. The septic system had been cleaned out three years ago.

Figure 9. Location of existing cesspool system.

The solution is to rehabilitate the old bathroom/cesspool system and finish the new bathrooms. It is recommended that both bathrooms be fully operational with an additional septic tank system if needed; the school will need these facilities if it ever plans to grow.

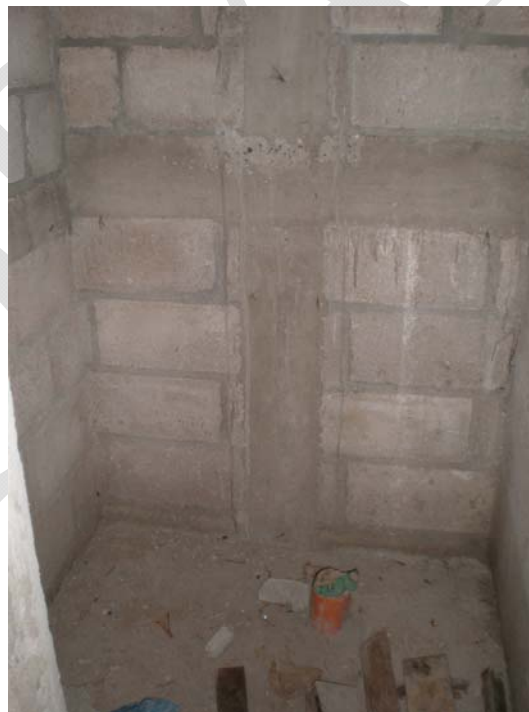
The school has begun constructing a new bathroom with six new toilet locations. The bathroom is not complete and still needs toilets. No new septic tank has been constructed. Vincentes stated that when the new bathrooms are completed the other bathrooms would be replaced with classrooms.

Figure 10. Toilet location in new bathroom.

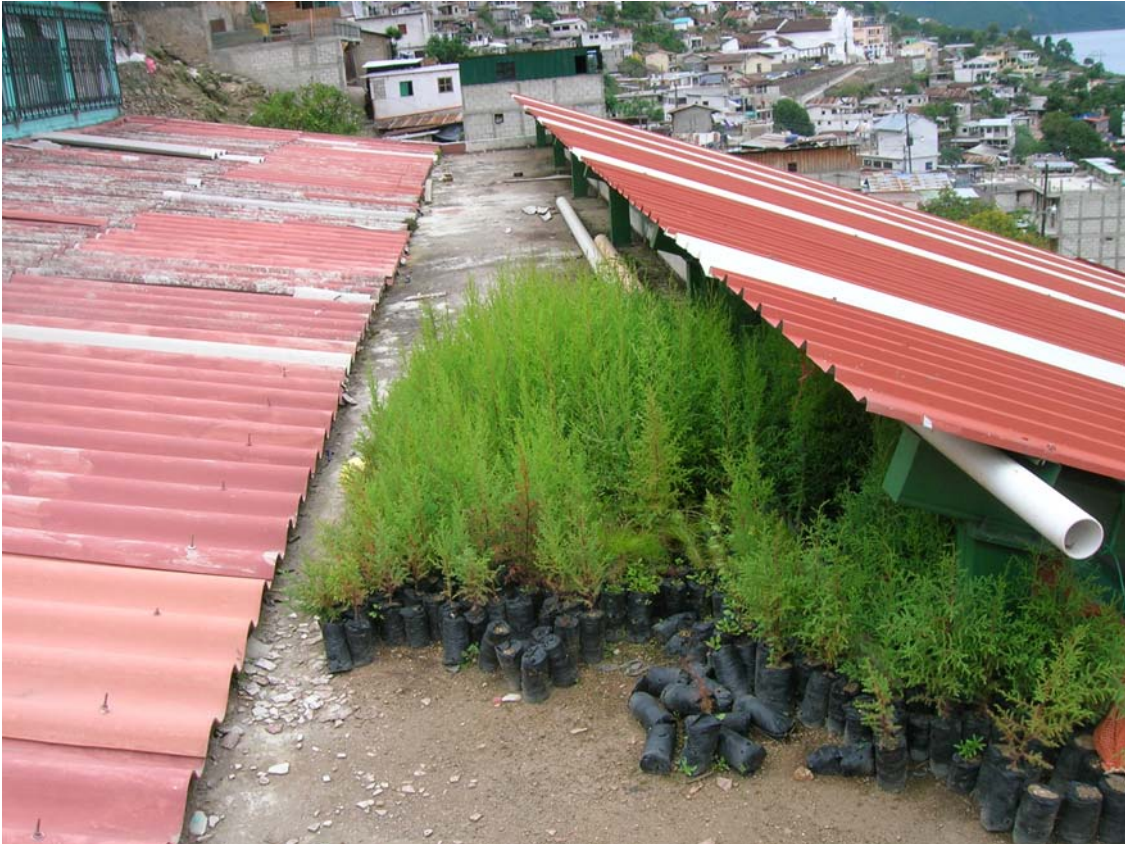
The school does have flattop roof on a portion of the school. This location could be used for expansion and additional classrooms if structurally feasible. Vincentes stated he has a set of plans.

Figure 11. Location of possible expansion.

Structural assessment
Building plans (if available)

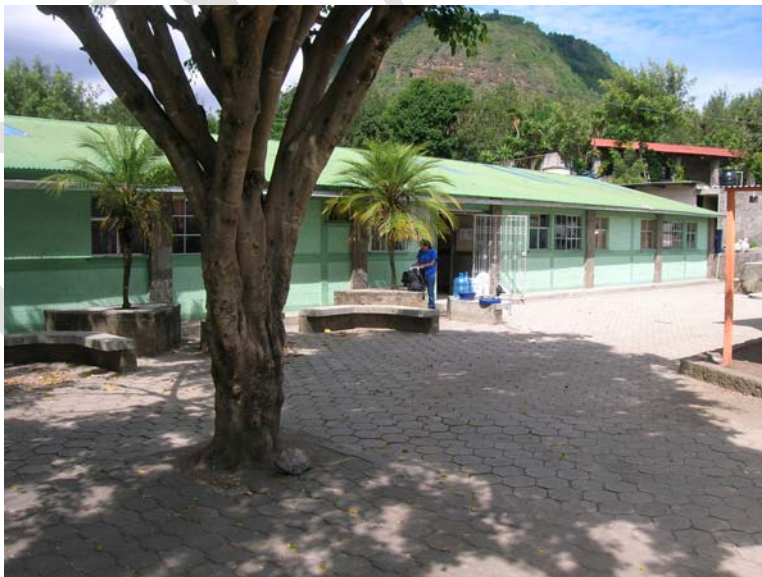
Angelica showed concerns that the kitchen smelled of sewer at times, there was limited light and ventilation in the bathroom, and the roof leaked over the kitchen/pantry area. Angelica has official building plans/blue prints for expansion of the bathroom building with associated building costs. She considers her school the school of the future and knows that her students are the leaders of tomorrow!

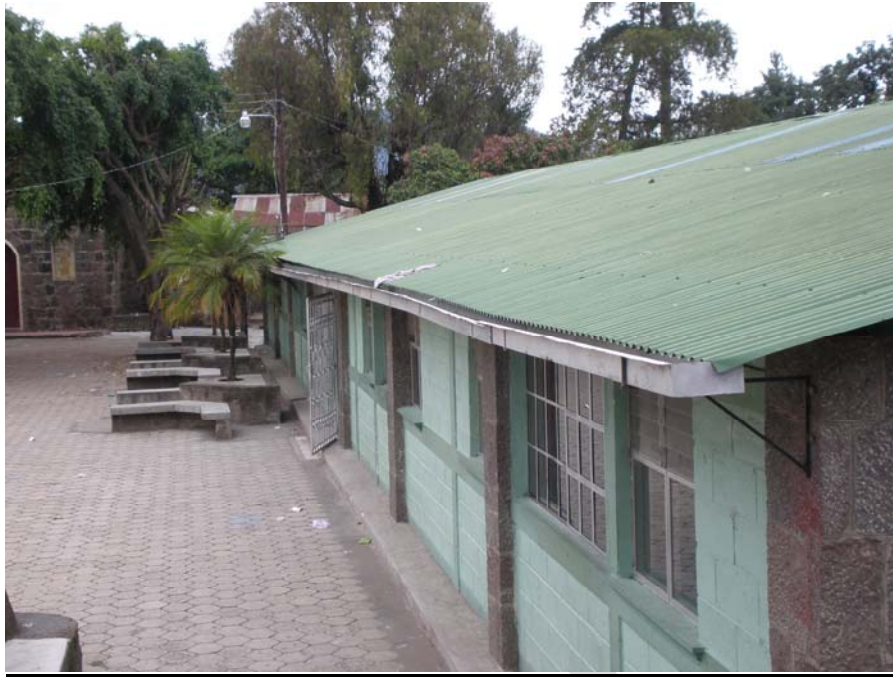
Figure 12. The school's roof and gutter system.

Establishing the school's own municipal tap should be first priority. Also, based on the school's water demands additional storage may be needed. Rain harvesting would be an easy addition to the schools water supply. The school has a tin roof and a gutter system all ready in place.

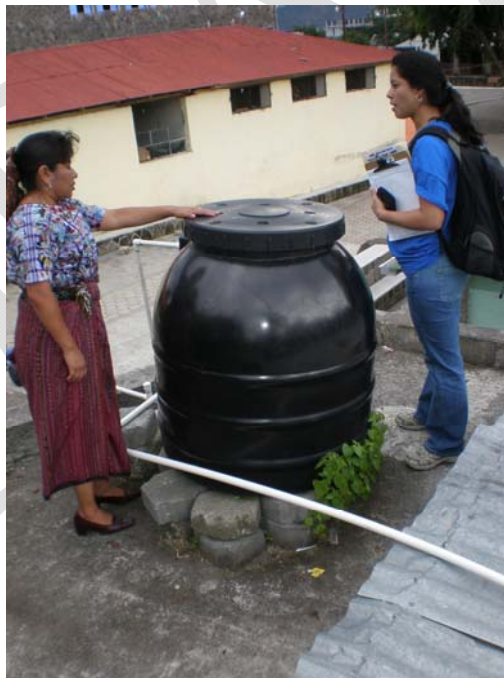
The school obtains their water by tapping into the mayor's building water line next door. Their own tap was broken/filled in during construction. The source of their water comes from a groundwater well downstream near the lake and is pumped uphill. Weekly their water supply goes out due to electricity or supply shortages. The school does have one RotoPlas tank for temporary storage and appears to be in working condition. The students do have access to the tank and have removed the lid at times. Some sort of security measure should be taken to limit the tank's accessibility.

Figure 13. The school's Rotoplas storage tank.

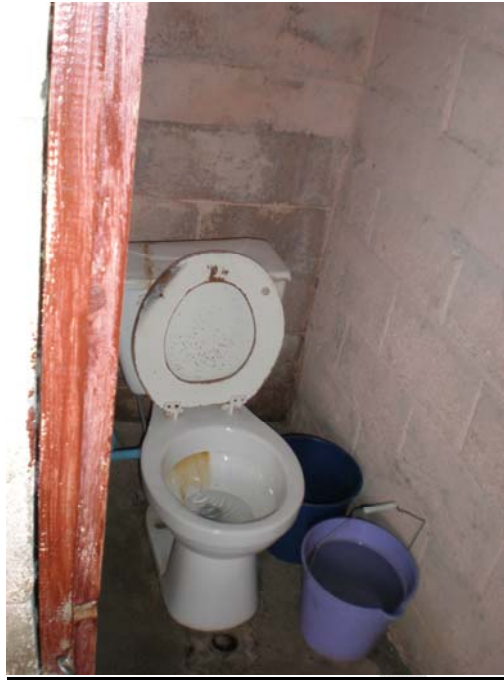
All of the school's current wastewater goes to a septic/cesspool system. According to Angelica there is no overflow problem, just an odor problem. This is likely due to the fact the kitchen wastewater pipe is connected to the bathroom wastewater pipe which continues to the septic tank.

Figure 14. Typical bathroom stall.

A simple solution to the odor problem would be to insert some sort of backflow prevention (flap-gate) in the kitchen's waste pipe and to properly ventilate the bathrooms. If expansions are made to the school, the current septic system should be analyzed to ensure its capacity can meet the school's demands.

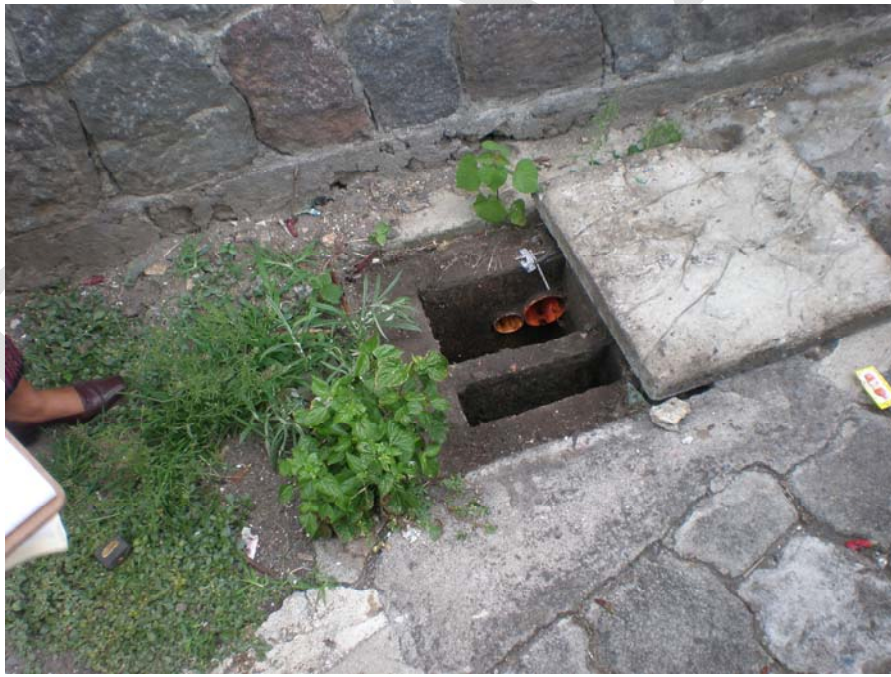
Figure 15. Septic system inlet box.

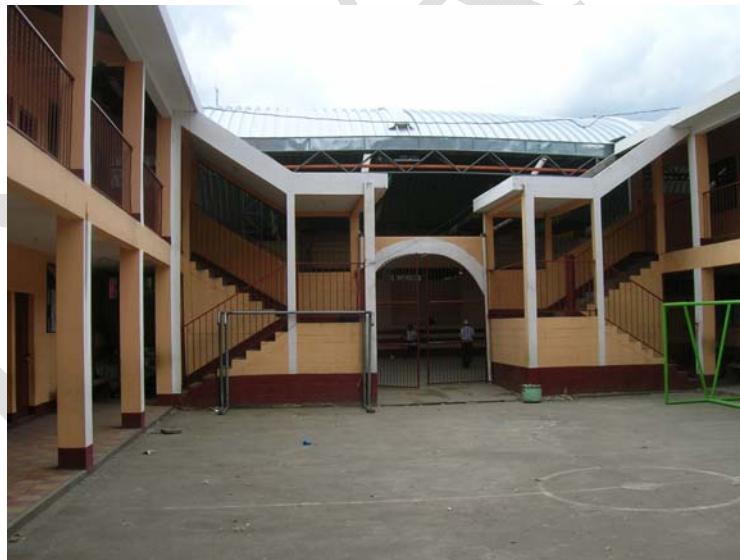
Carlos stated several concerns such as lack of school supplies, student malnutrition and attendance; however, the biggest infrastructure/engineering concern was the existing sanitary system. The school has one bathroom with four toilets and there is no separation of boys and girls. The septic system overflows regularly.

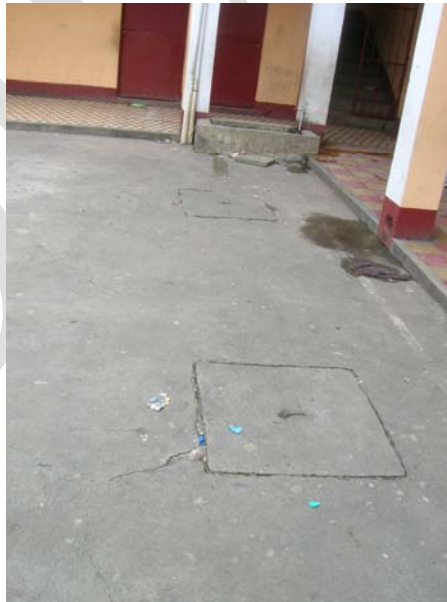
There were no stated concerns with the water supply. The source of the water was not identified. During the site visit water was available. The PVC piping in the water tap had a small crack; therefore water had to be turned off and on each time it was needed. Carlos stated he was going to fix the problem when the supplies arrived.

Figure 16. Location of school tap and location of septic system.

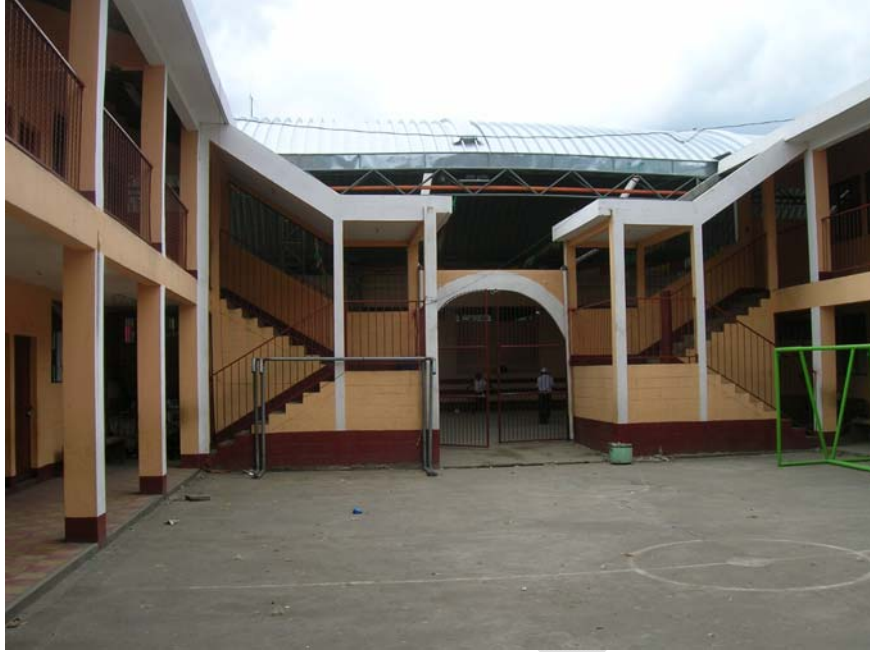
As stated the existing sanitary system is regularly overloaded. The facilities at the school are not capable of handling the amount of wastewater created at the school. Carlos stated that the space underneath the stairwells could be possible locations for new bathrooms. There is limited area outside the school grounds for leach fields or extra septic systems. There is one 20' x 8' area that could be used; however, would have to be investigated because of structural issues.

Figure 17. Possible location of additional bathrooms under each stairwell.

The solution is to rehabilitate the old bathroom/cesspool system and to construct additional bathrooms that connect to a separate sanitary system. It is recommended that both bathrooms be fully operational to handle the daily quantity of wastewater. The existing system will need to be cleaned and its capacity analyzed.

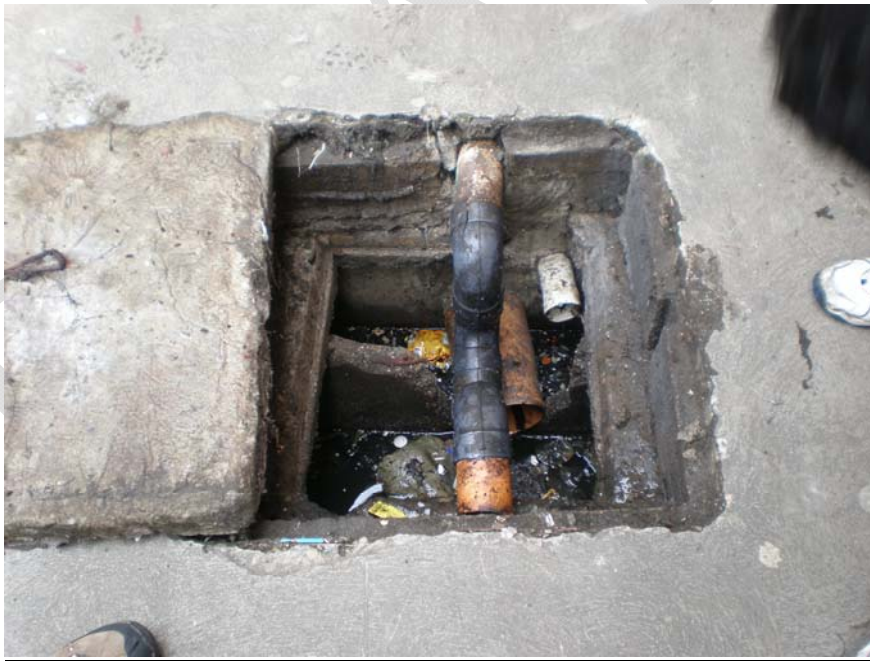
Figure 18. Existing septic system entrance box.

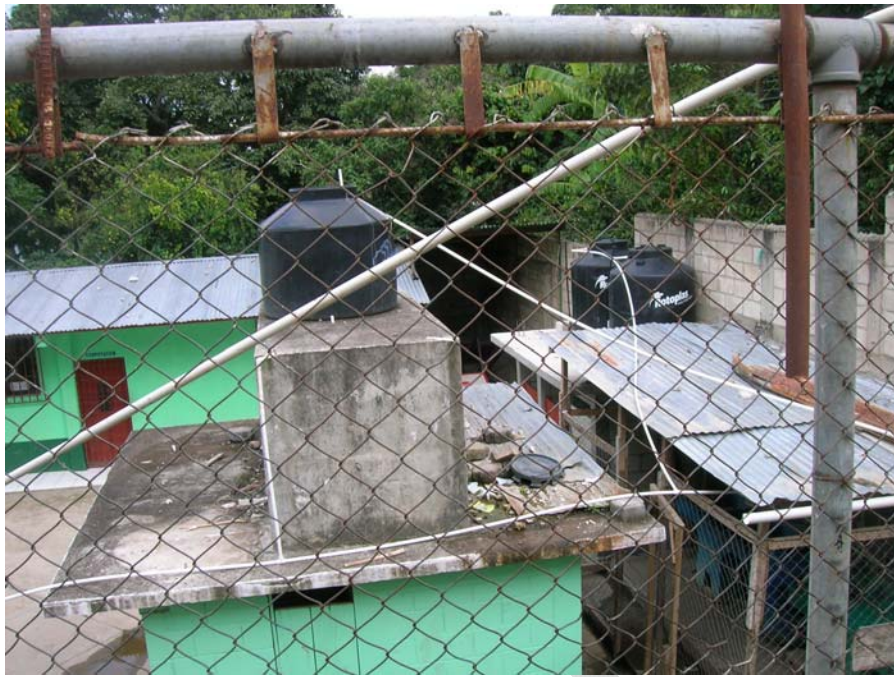
The water supply was readily available during our visit. The source of water was never identified. The school has six Rotoplas tanks, however only three appeared to be in working condition. The tanks that were not functional appeared to be missing floats, lids, and piping.

Figure 19. Rotoplas tanks above bathroom buildings.

Assuming the water supply is sufficient and consistent the school has no immediate water supply problems. However, the school could increase their water supply storage and emergency supplies by simply fixing their existing infrastructure.

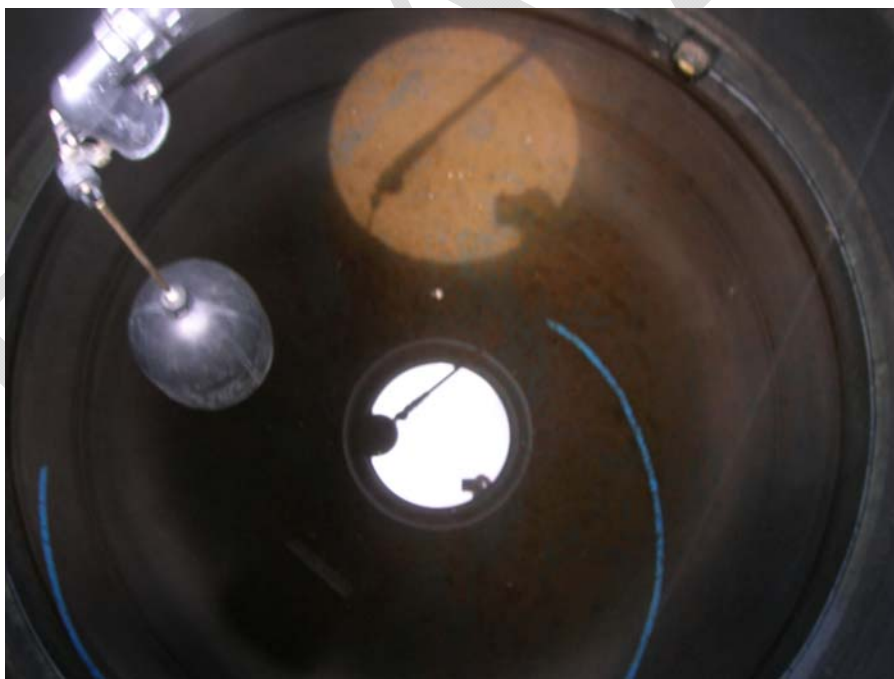
Figure 20. Empty Rotoplas tank with no water connection.

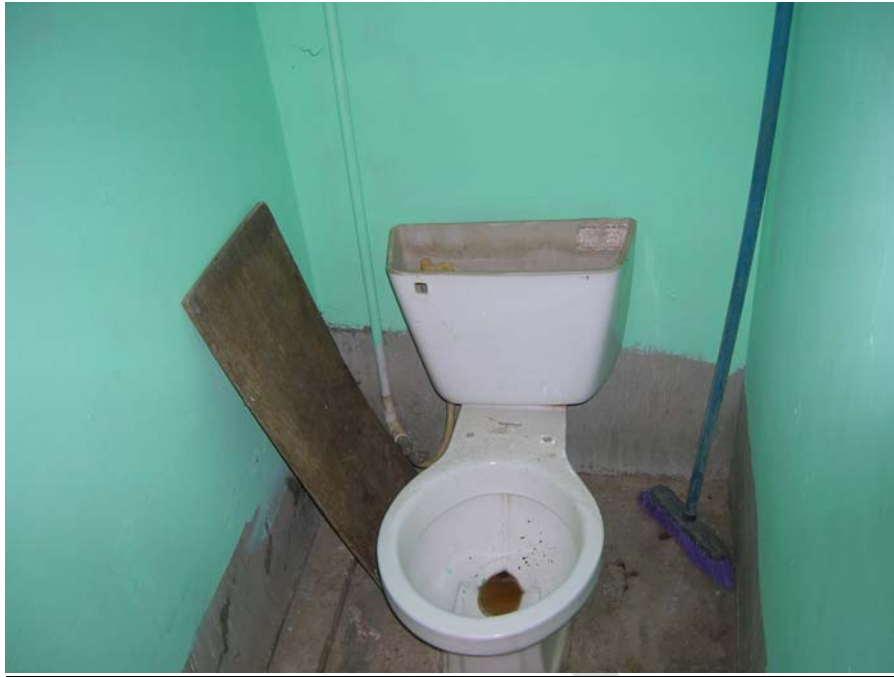
The existing sanitary system consists of a septic/cesspool system. The system's entrance manhole could not be located. According to the school's representative the system does not overflow (verification needed). The school added new bathrooms during school's expansion and it was stated a new septic system was included (verification needed). The school has three bathroom buildings; two for students and one for teachers. Three of toilets in the teachers building do not function; it appears this may be due to the fact there is no water supply. The Rotoplas tank that supplies water to these toilets is not operating and has no water source.

Figure 21. Typical bathroom stall.

The sanitary issues are minimal. Fixing the water supply or Rotoplas conditions should fix the toilets that are not functioning.

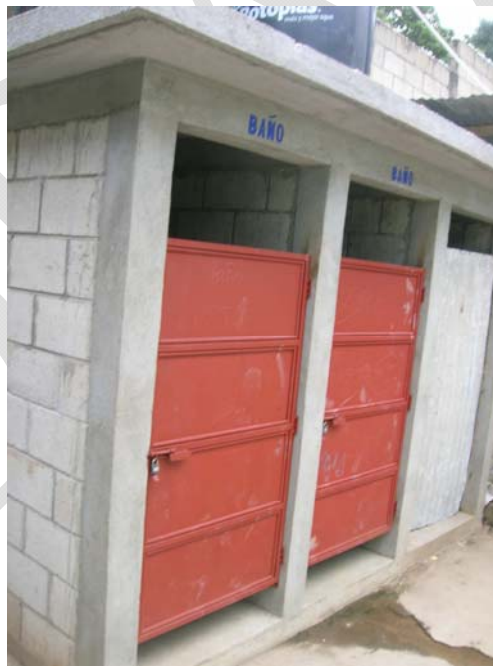
Figure 22. The teacher's bathroom building.
